## Encoder Issue in MR-J5 HK Servo Motor

May 22, 2023

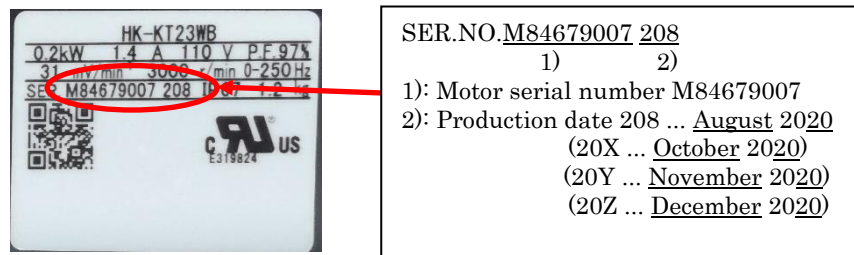
Figure 1. Checking on the product

Check "SER.NO." on the rating plate attached to the side of the product. (Figure 1)

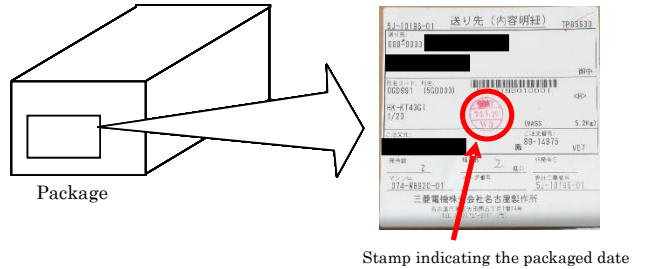
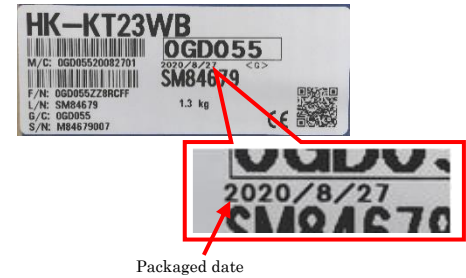
Figure 2. Checking on the packaging box

Check the date on the label attached to the packaging box of the affected product mentioned above.

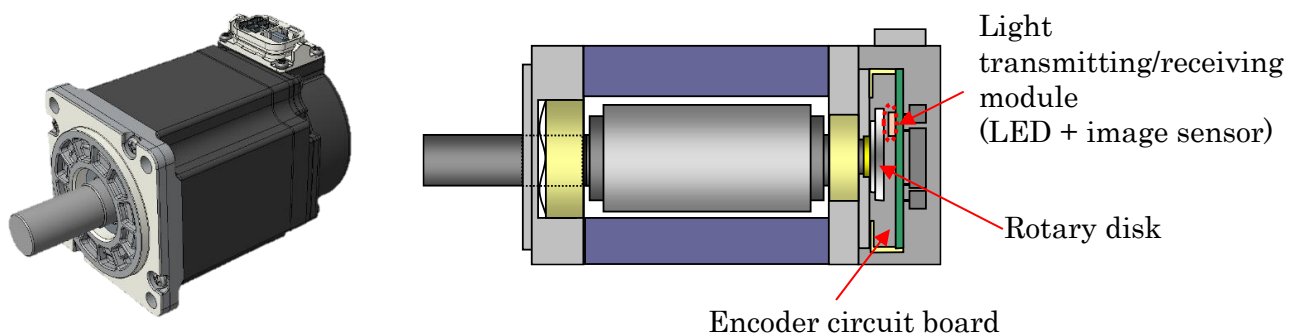
Figure 3-1 Diagrammatic sketch of a servo motor

- (1) In the investigation of the faulty product, a line was found on the side of the light emitting window (Figure 3).
- (2) The brightness of the LED was different from that of the normal products. In addition, a dark line was found in the light emitting window (Figure 4).
- (3) From the position relation between the line on the side of the light emitting window and the dark line in the LED light emitting window, the dark line was confirmed to be aligned with the line (Figures 3 and 4).
- (4) We presume that the line on the side of the light emitting window had extended inside and reached the light emitting window, causing the crystal fault. This is considered to have generated the dark line, which consequently decreased the illuminance of the LED. The decrease in the illuminance prevents the position data from being properly generated, resulting in an alarm (AL021.1) occurrence.

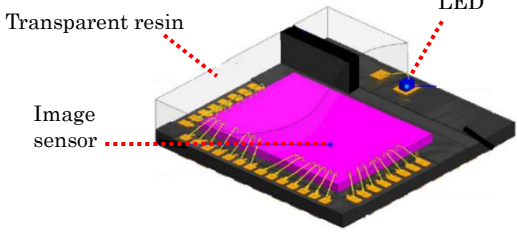
In the manufacturing process of the light transmitting/receiving module package, compressive stress is applied to LEDs when the temperature returns to room temperature after transparent resin sealing. This causes lines in some of the products depending on the durability of the LED itself or the unevenness in the resin material.

<ul style="list-style-type: none"> <li>• The LED and image sensor are entirely covered with transparent resin molding. (for protection during assembly) → A line appears in the LED (which causes the failure) due to the stress caused by temperature drop after resin molding.</li> </ul> <p>Figure 6 (Light transmitting/receiving module with the design before change)</p>

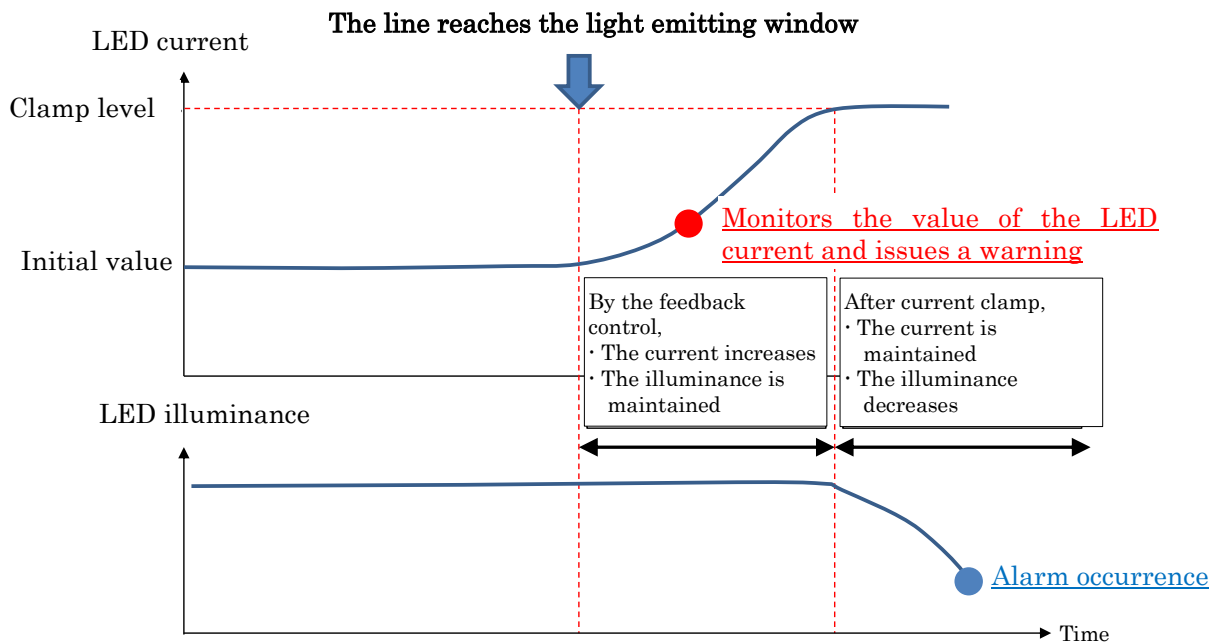
Figure 8. Conceptual figure of the diagnosis function in the batteryless absolute position encoder

As shown in Figure 8, if the line on the LED edge surface extends into the light emitting window, the LED current feedback control inside the encoder increases the LED current value to make the illuminance even. After the LED current value reaches the clamp level, the LED current value becomes even and the LED illuminance decreases. Therefore, monitoring the LED current value enables detection of signs of illuminance decrease. This diagnosis function cannot detect symptom 2 mentioned below because the function is applicable only to symptom 1. The latest firmware version of the MR-J5 is available by downloading from the Mitsubishi Electric FA site. To enable this function on servo amplifiers with firmware version D1 or later, some of the undisclosed parameters need to be changed. Please contact your local sales office when introducing this function.

To detect signs of line development on the LED before LED illuminance decrease occurs causing an alarm (AL021.1), the diagnosis function has been added to the AC servo amplifier MR-J5 (with firmware version D1 or later).
