January 21, 2021 B.Ref.: BQN-S₃2870-71-211908 *

Inverter FR-D700, FR-F700 PJ Series Storage Element IC (EEPROM) Product Quality Issue – STOP SALE NOTICE - Immediate Attention Needed

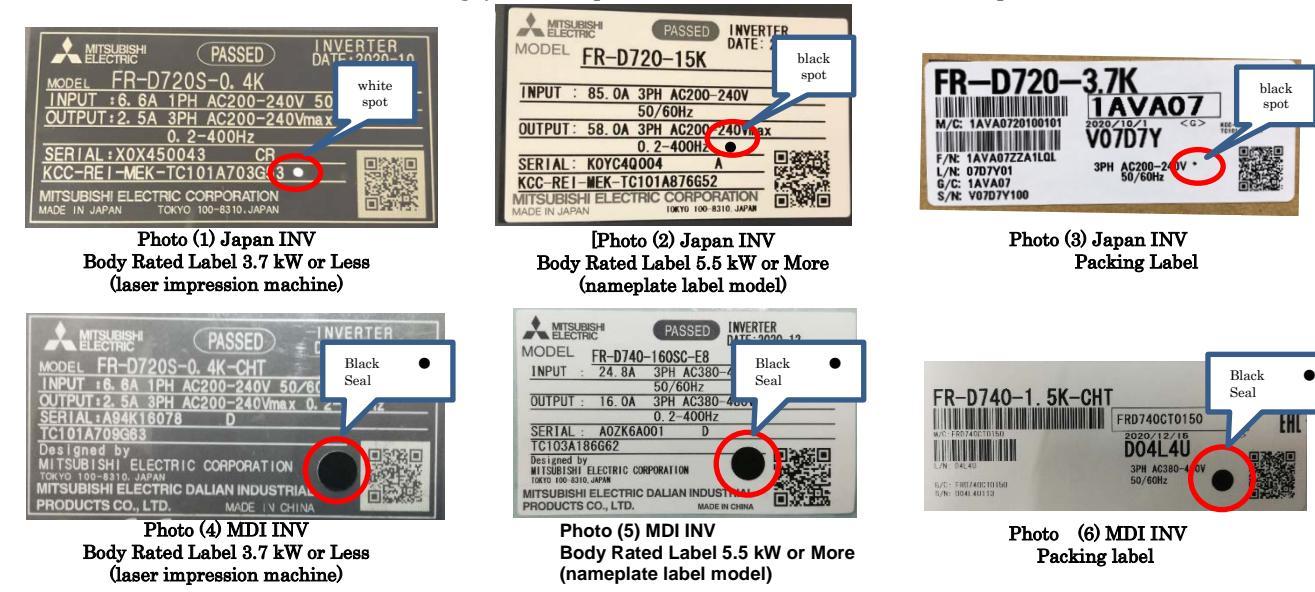
[Target Serial Number] □06 ○○○○○○: Made in Jun. 2020 to □0Z ○○○○○○: Made in Dec. 2020 *1: The product with the identification shown in the photograph below are NOT applicable to defects because they have countermeasured EEPROM.

[How to identify products which are NOT applicable to defects]

A spot for identification will be added to the main body name plate and packing name plate. (Please refer to Photo 1 to 3 for the Nagoya Works products.) Photo 4 to 6 for the MDI products.)
